## **DART SERVICE BULLETIN SB10-6**

## AFFECTING:

D350-561-141 SINGLE MIRROR INSTALLATION AT CHANGE 002 OR EARLIER D350-561-143 DUAL MIRROR INSTALLATION AT CHANGE 002 OR EARLIER

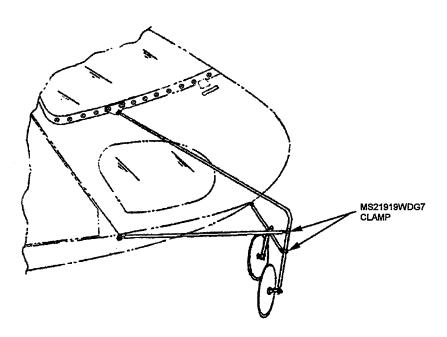
## FIGURE 1

For D350-561-141/-143 mirror kits, the MS21919WDG7 clamps have been replaced with stonger D4070-041 clamps. For customers with D350-561-141/-143 mirror kits at change 002 or earlier, it is recommended that the MS21919WDG7 clamps be replaced with D4070-041 clamps.

D350-561-143 DUAL MIRROR INSTALLATION (SHOWN)
D350-561-141 SINGLE MIRROR INSTALLATION (SIMILAR)

The DSI-9379-013 kit is available from DART to upgrade affected installations. Please see Dart Service Instruction **DSI 9379 Rev. C** (or later revision) for further information.
